CRAZING RESISTANCE

Crazing in glazed ceramic tiles

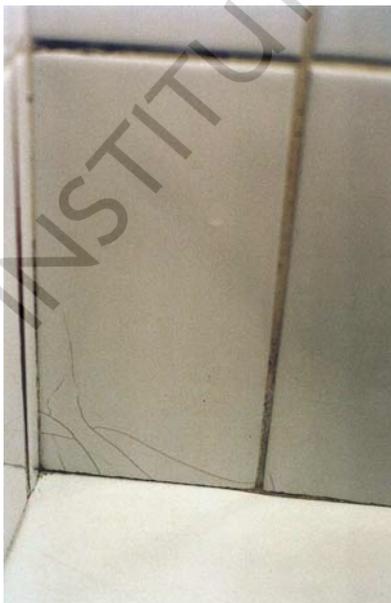
Crazing in BIII GL tile, at the juncture with the sanitary ware and change of plane

The appearance of crazing in particular tiling surfaces deserves special mention (e.g. in tiles at junctures with sanitary ware, kitchen benchtops, tiles bordering carpentry, etc.). In these cases, localised microcracking appears, caused by strong compression of the tile that abuts rigid elements and, in some cases, is subject to variable stresses, as a function of the presence of water or linear thermal expansion of the abutting materials.

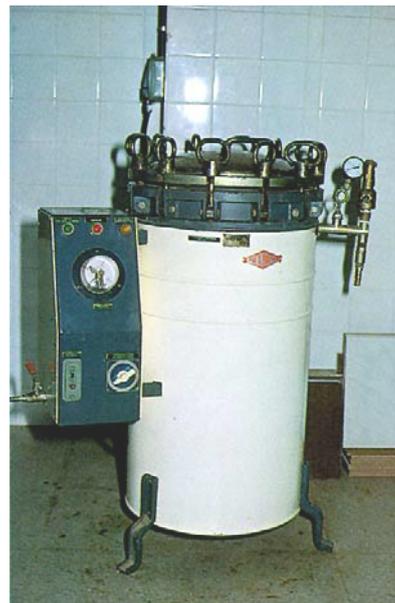
Autoclave for the crazing resistance test. Sebastián Carpi Laboratory (Castellón, Spain)

The test in the autoclave, at 500 KPa pressure and 160°C, gives rise to that stress, which can lead to rupture of the glaze.

- Refiring of the test tiles up to 500 °C, in a heating process of 150 °C/h, holding peak temperature for at least 2 h.
- Arrangement of the pieces in the autoclave, in order to subject them to heating (up to 159 °C) and increasing pressure [up to (500 ± 20) kPa in one hour] in a humid environment. The maximum pressure is held for two hours. Once that time has elapsed, the vapour supply is shut off and the pressure is lowered as rapidly as possible until atmospheric pressure and room temperature are reached.
- After the methylene blue stain has been brushed on to the glazed surface, this is wiped off with a damp cloth and the surface is visually analysed (at 25-30 cm, with lighting of 300 lux) to detect the presence of any crazing. The presence of hairline cracks in the surface of a single tile will entail a negative report in regard to crazing resistance.

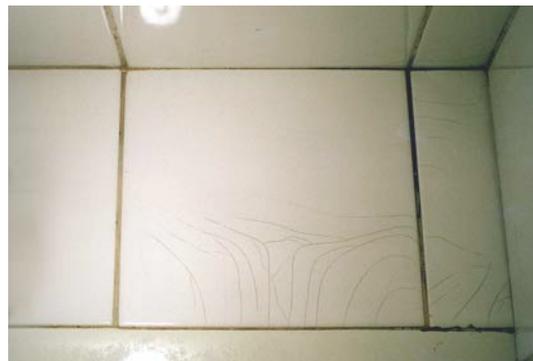
Crazing resistance in ISO 10545-11
